NATIONAL BUREAU OF STANDARDS REPORT

2163

MOISTURE-RESISTANT COATINGS FOR WALLS OF STRUCTURES USED FOR STORAGE

Edward R. Oglio and William C. Cullen

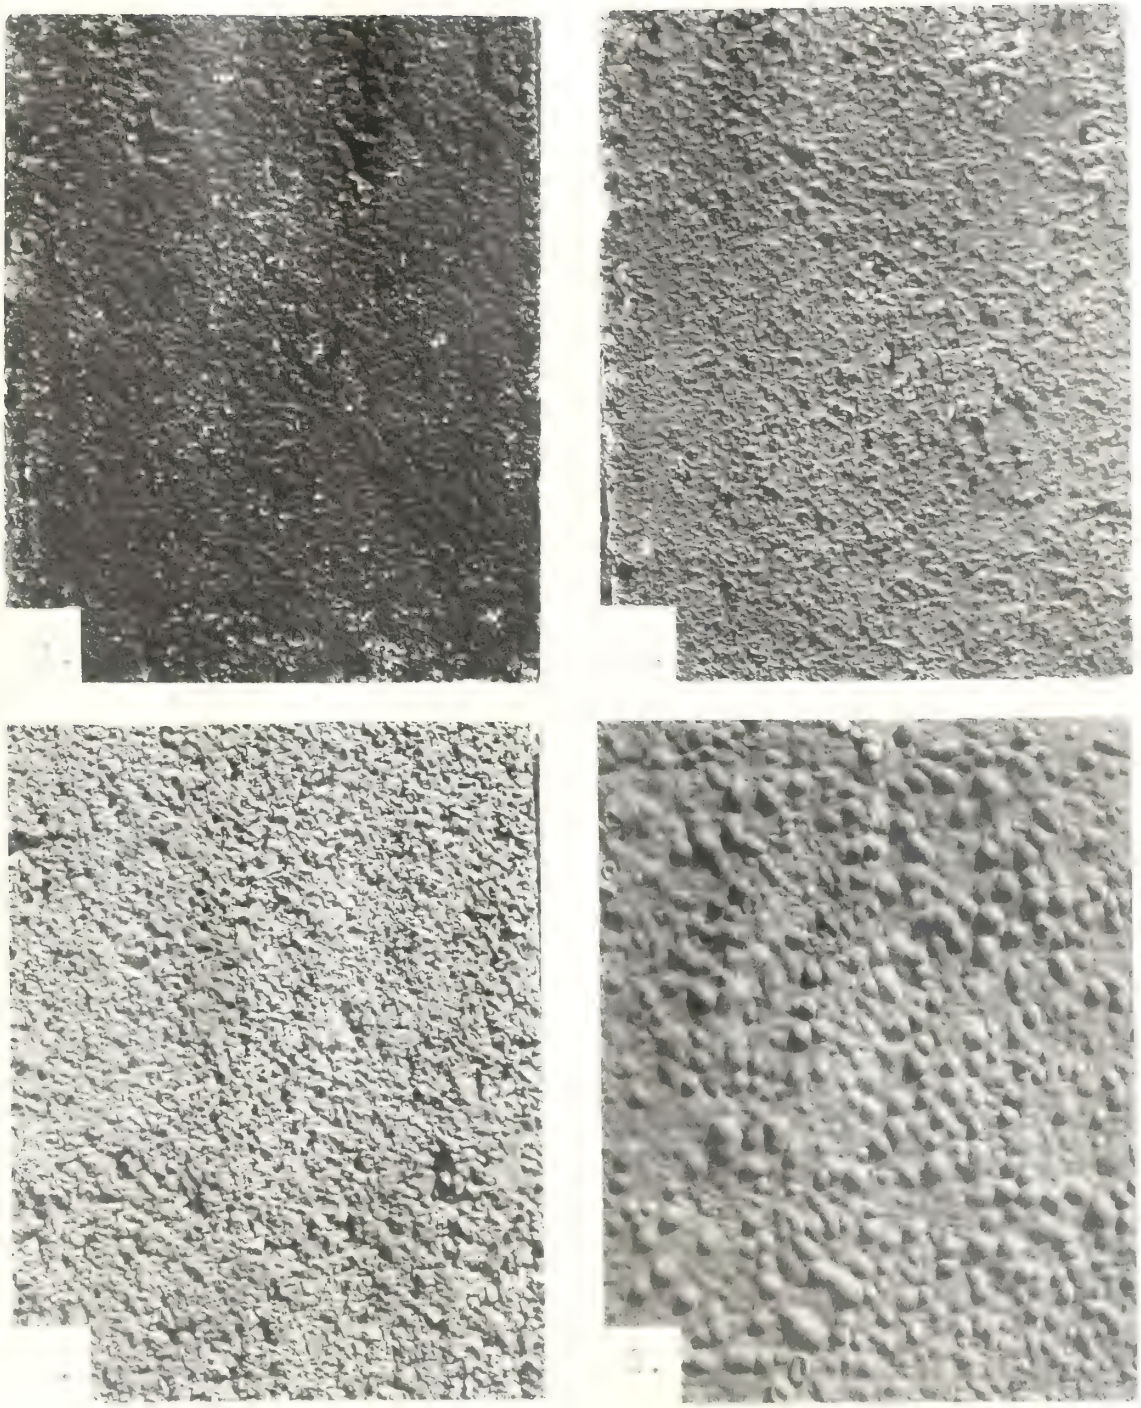
Figure 3. Class I coatings on cinder block - 2 years outdoor exposure.

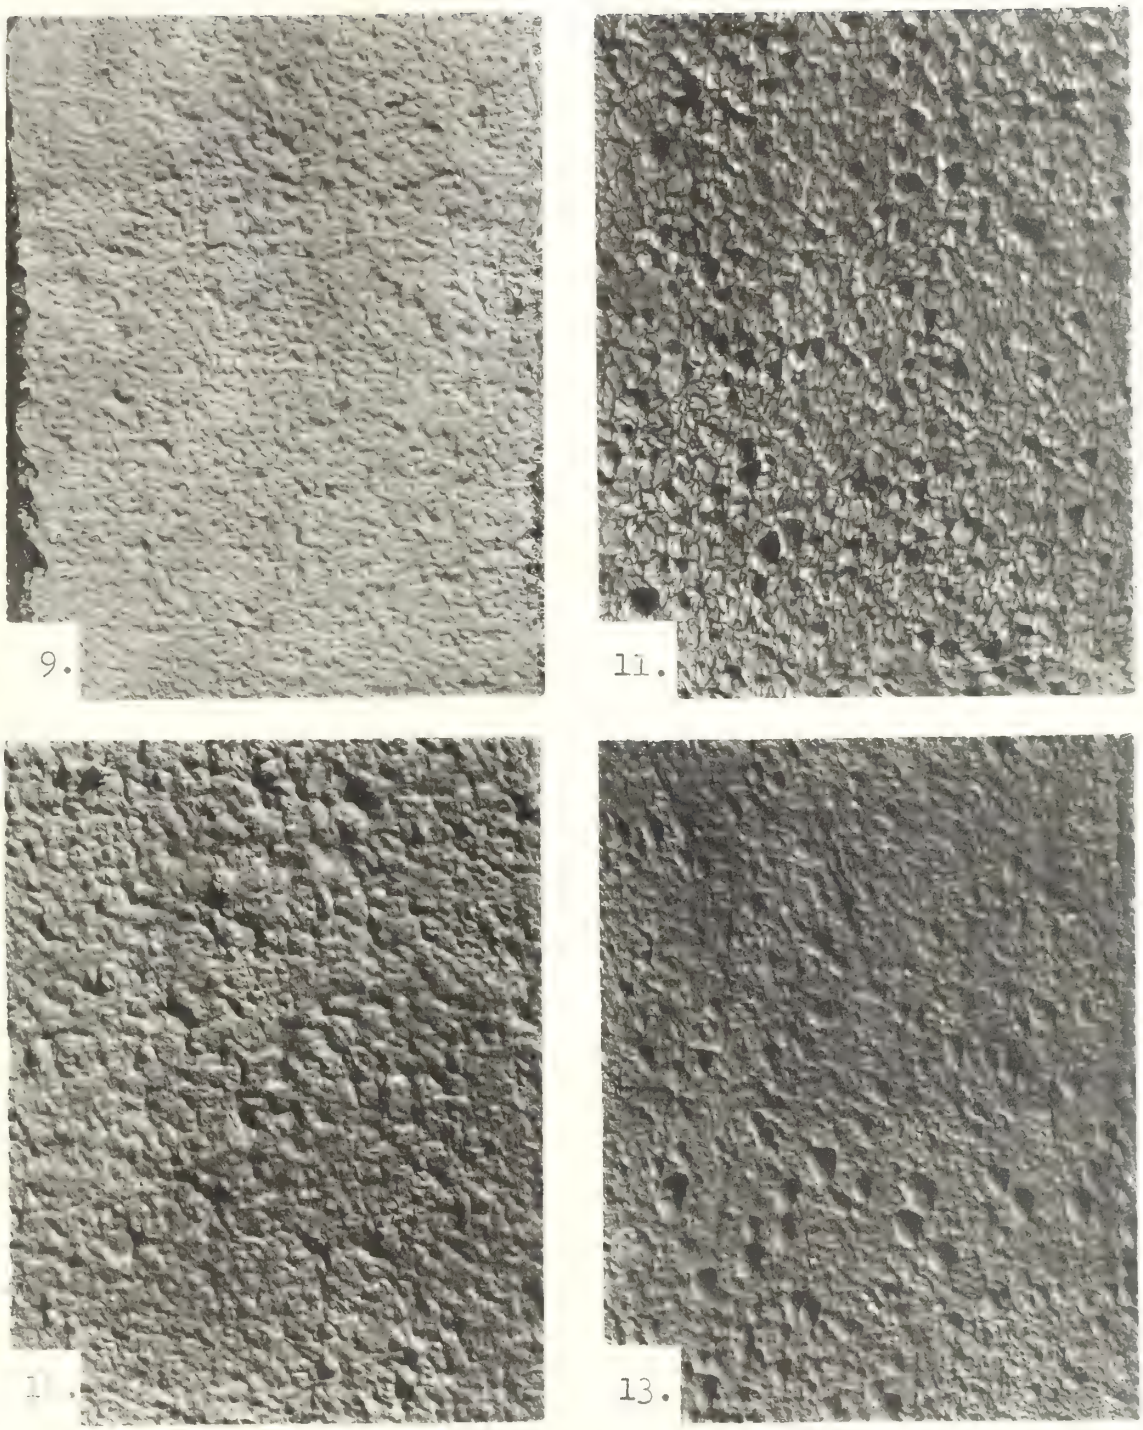
Figure 4. Class I coatings on cinder block - 2 years outdoor exposure.

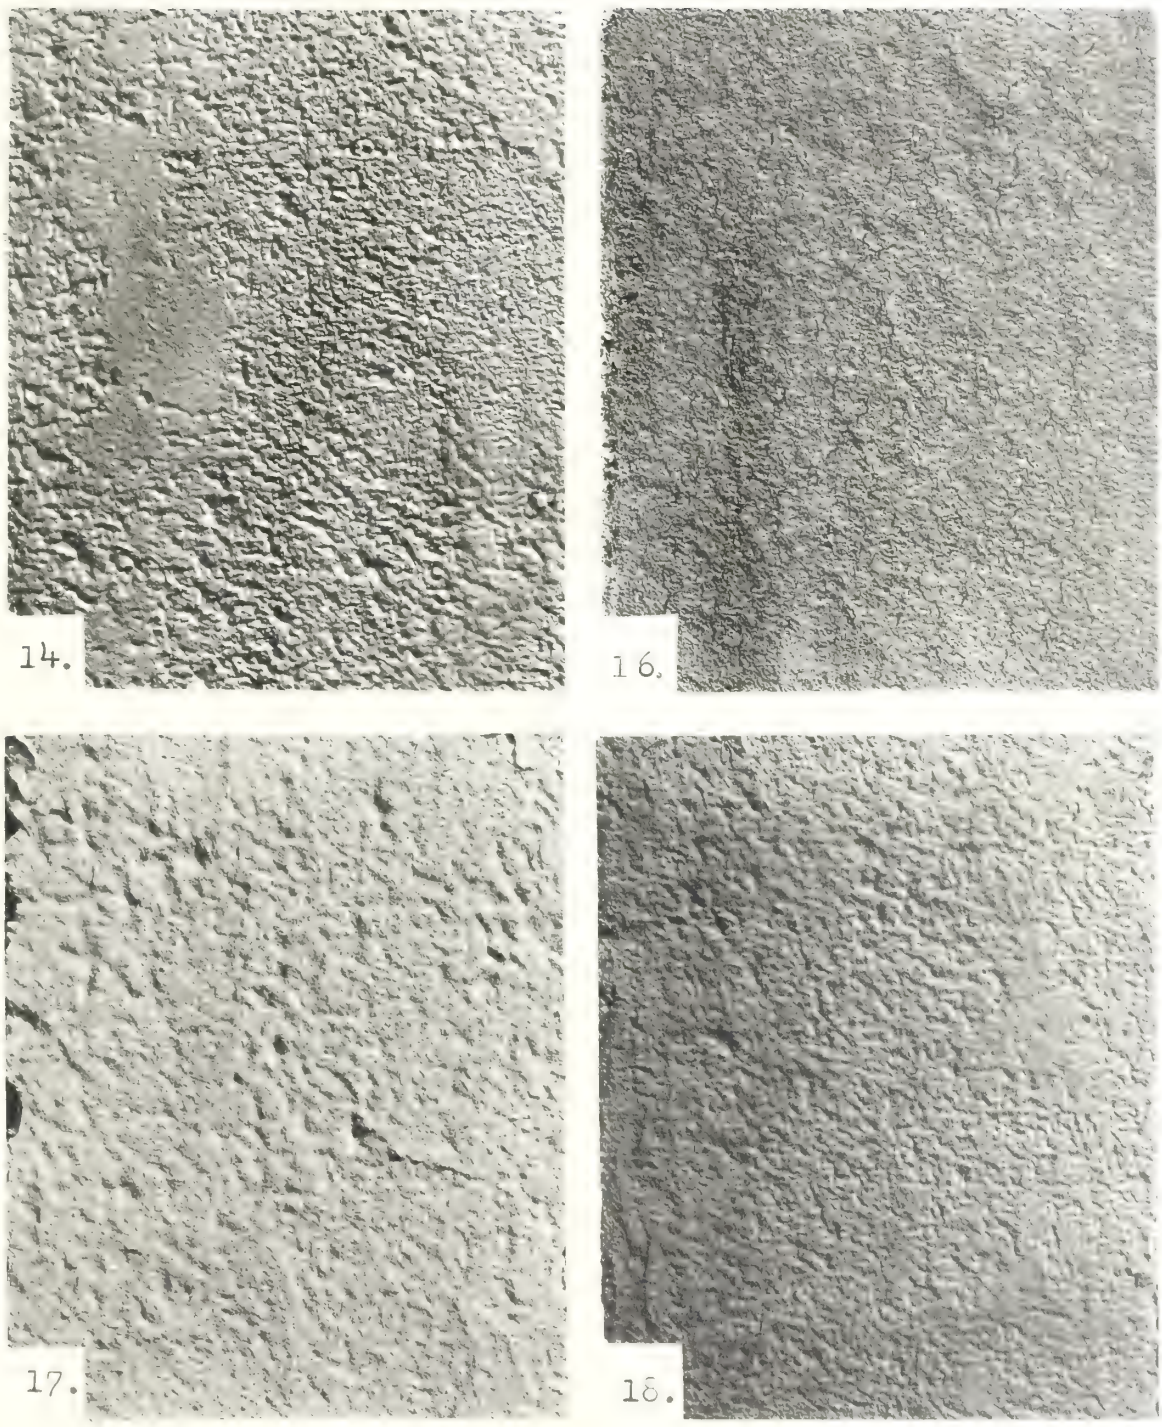
Figure 5. Class I coatings on cinder block - [illegible] years outdoor exposure.

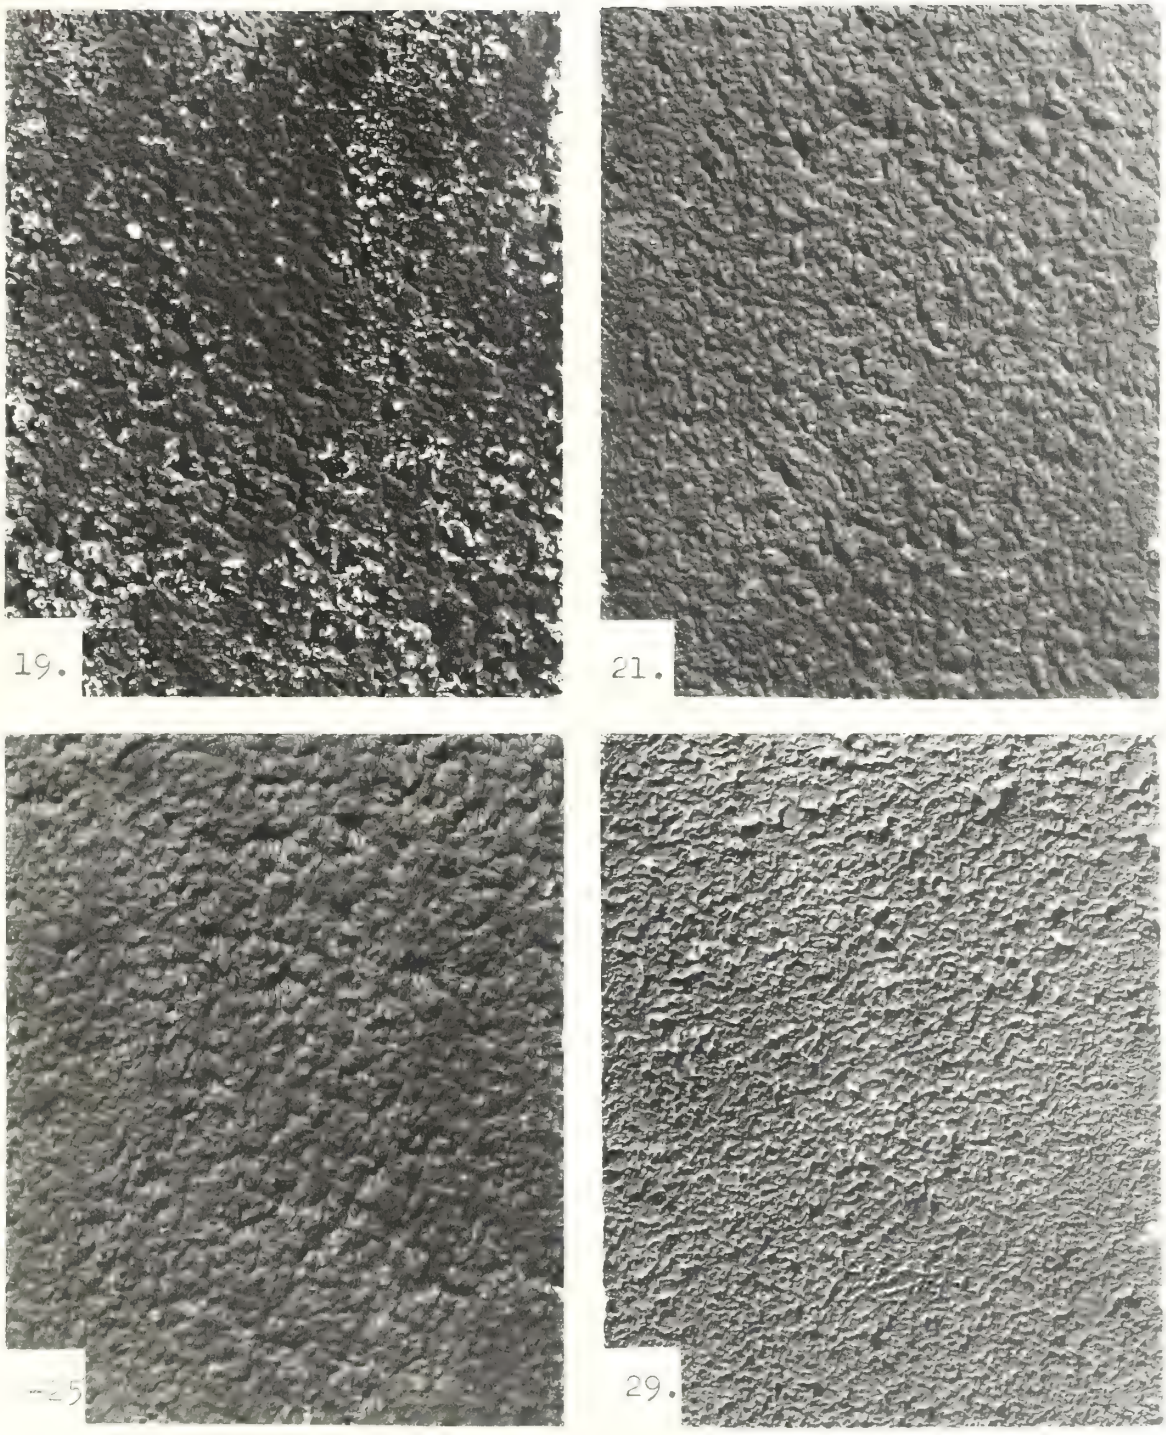
Figure 6. Class I coatings on cinder block - 2 years outdoor exposure.

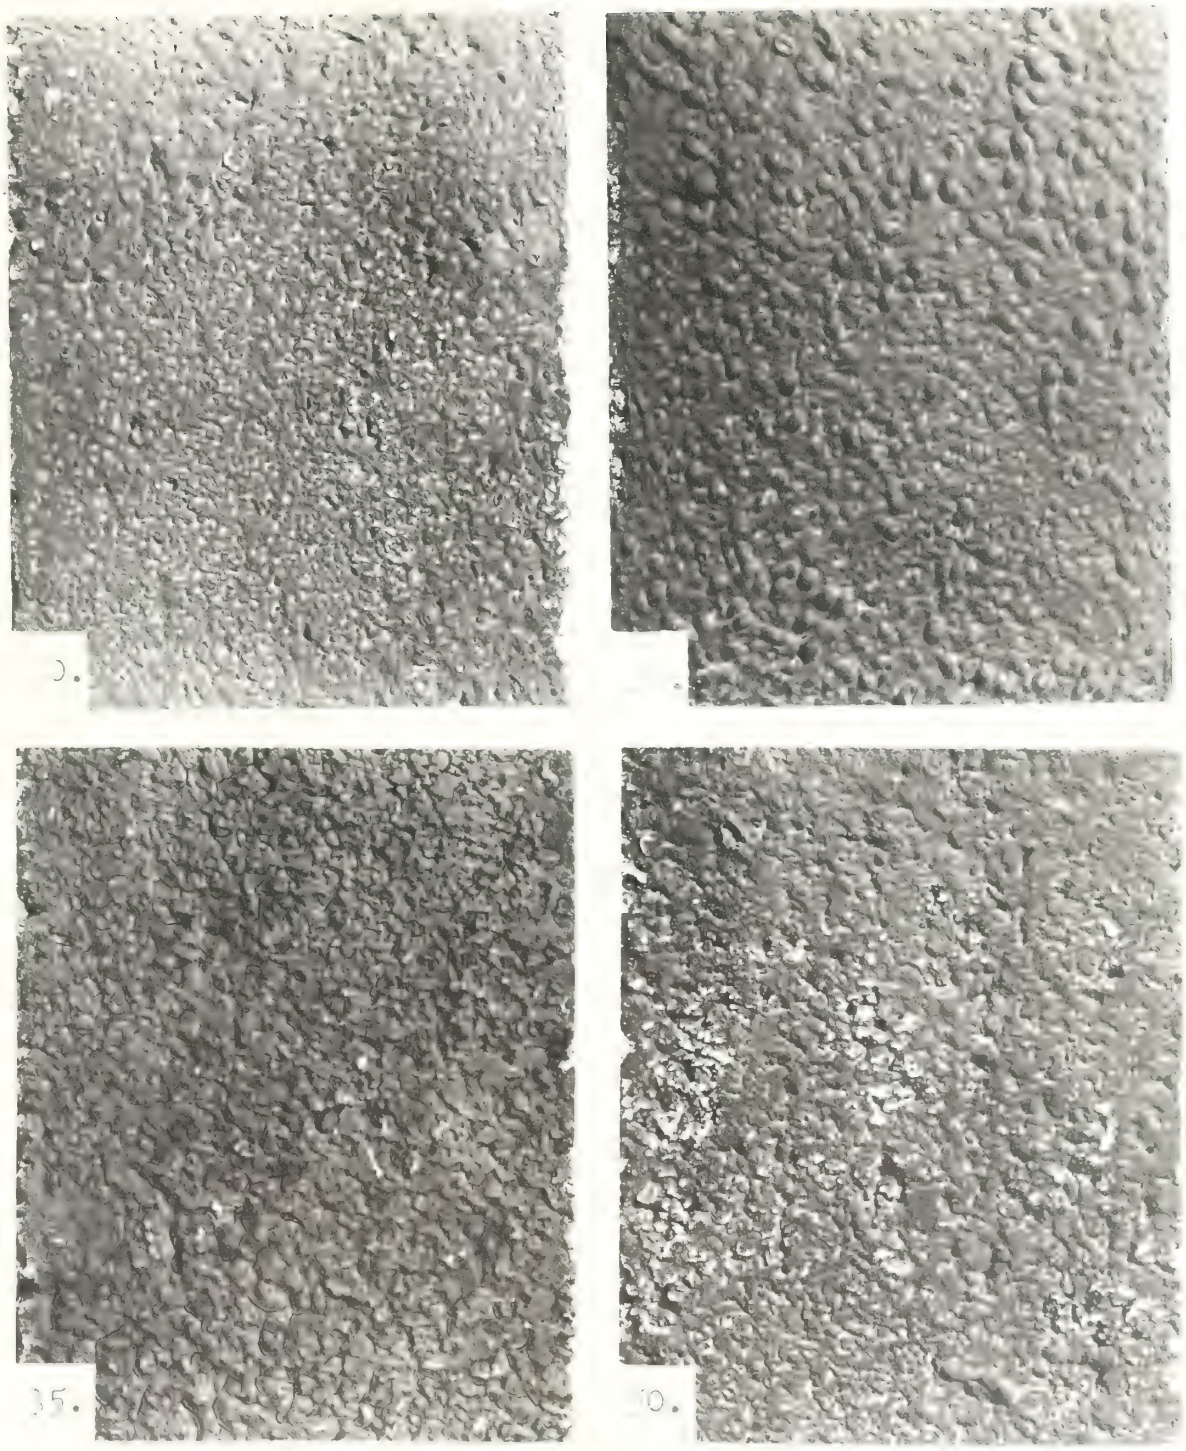
Figure 7. Class I coat... on cinder block - 2 years outdoor exposure.

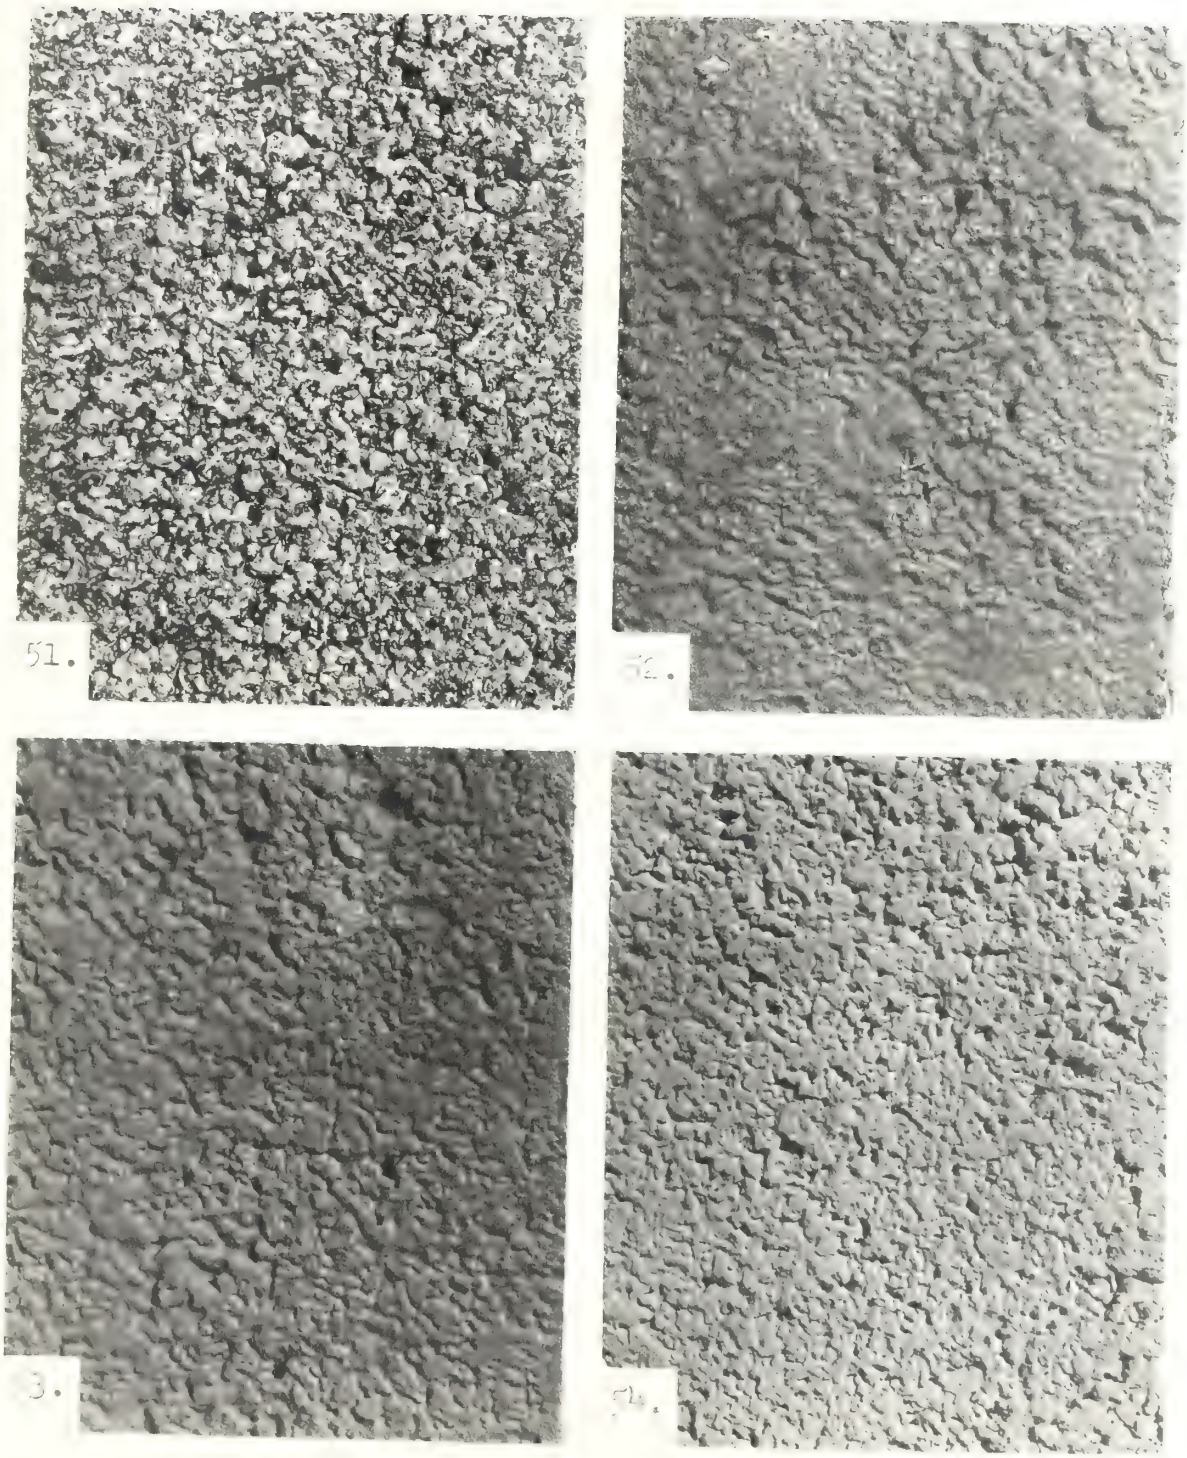
Figure 8. Class I coatings on cinder block - 2 years outdoor exposure.

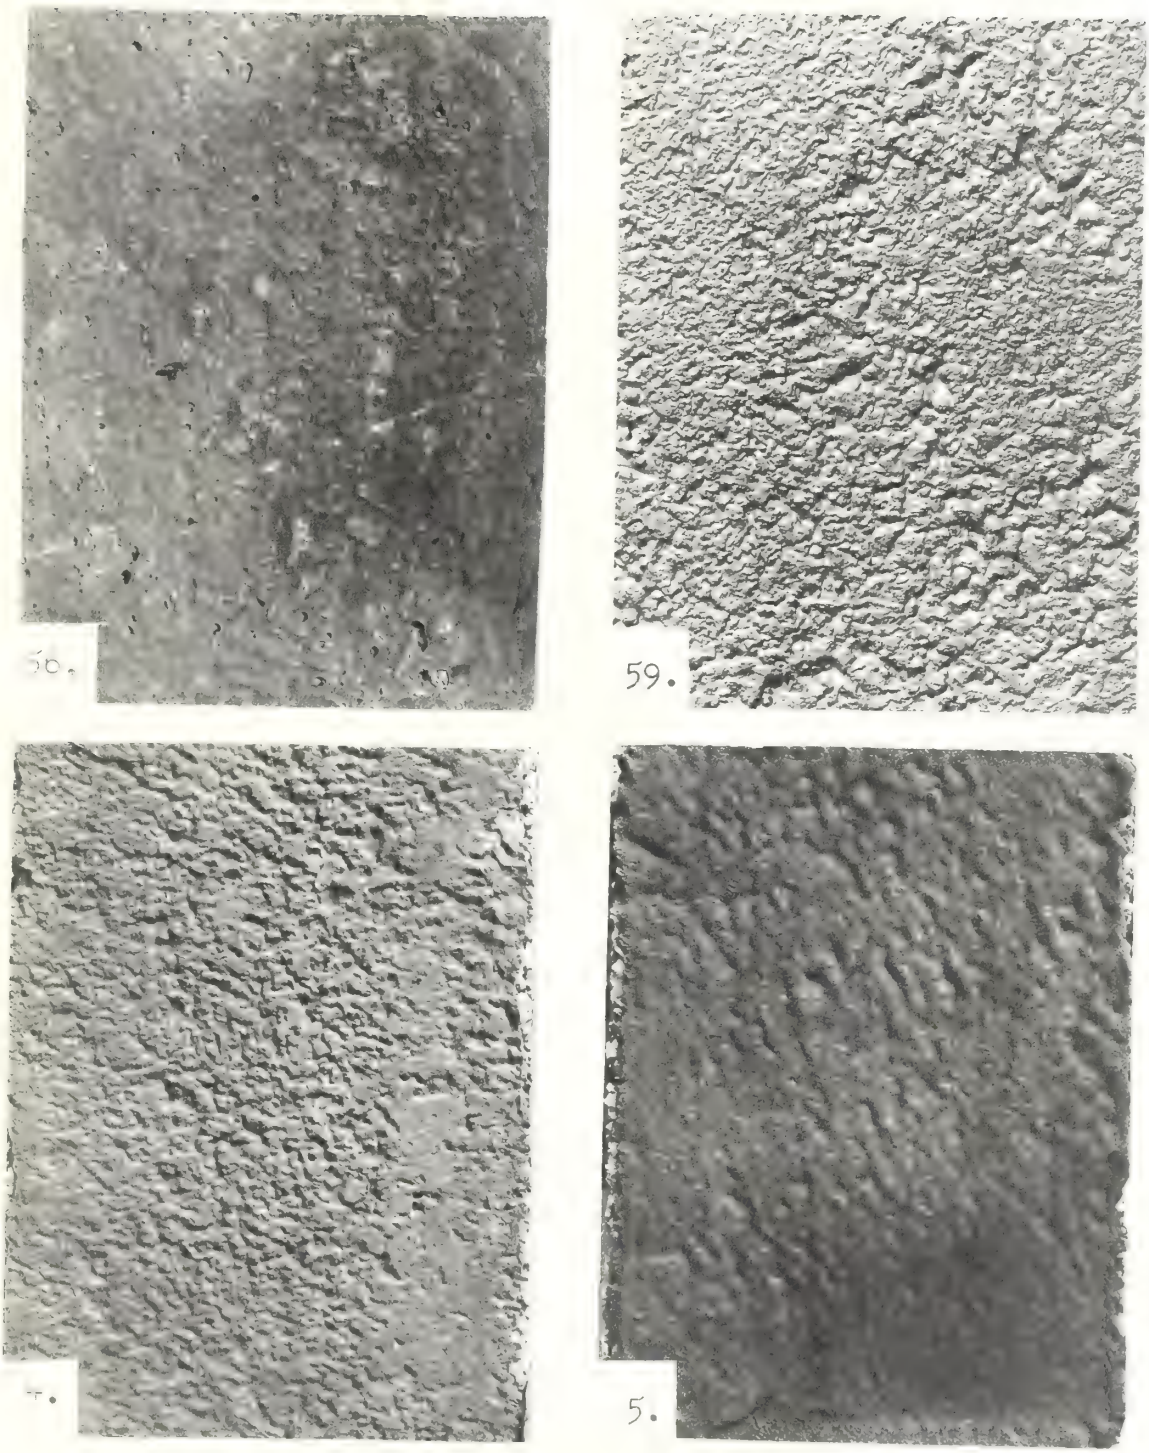
Figure 9. Coatings on cinder block - 2 years outdoor exposure.
56 & 59, Class I coatings; 4 & 5, Class III coatings.

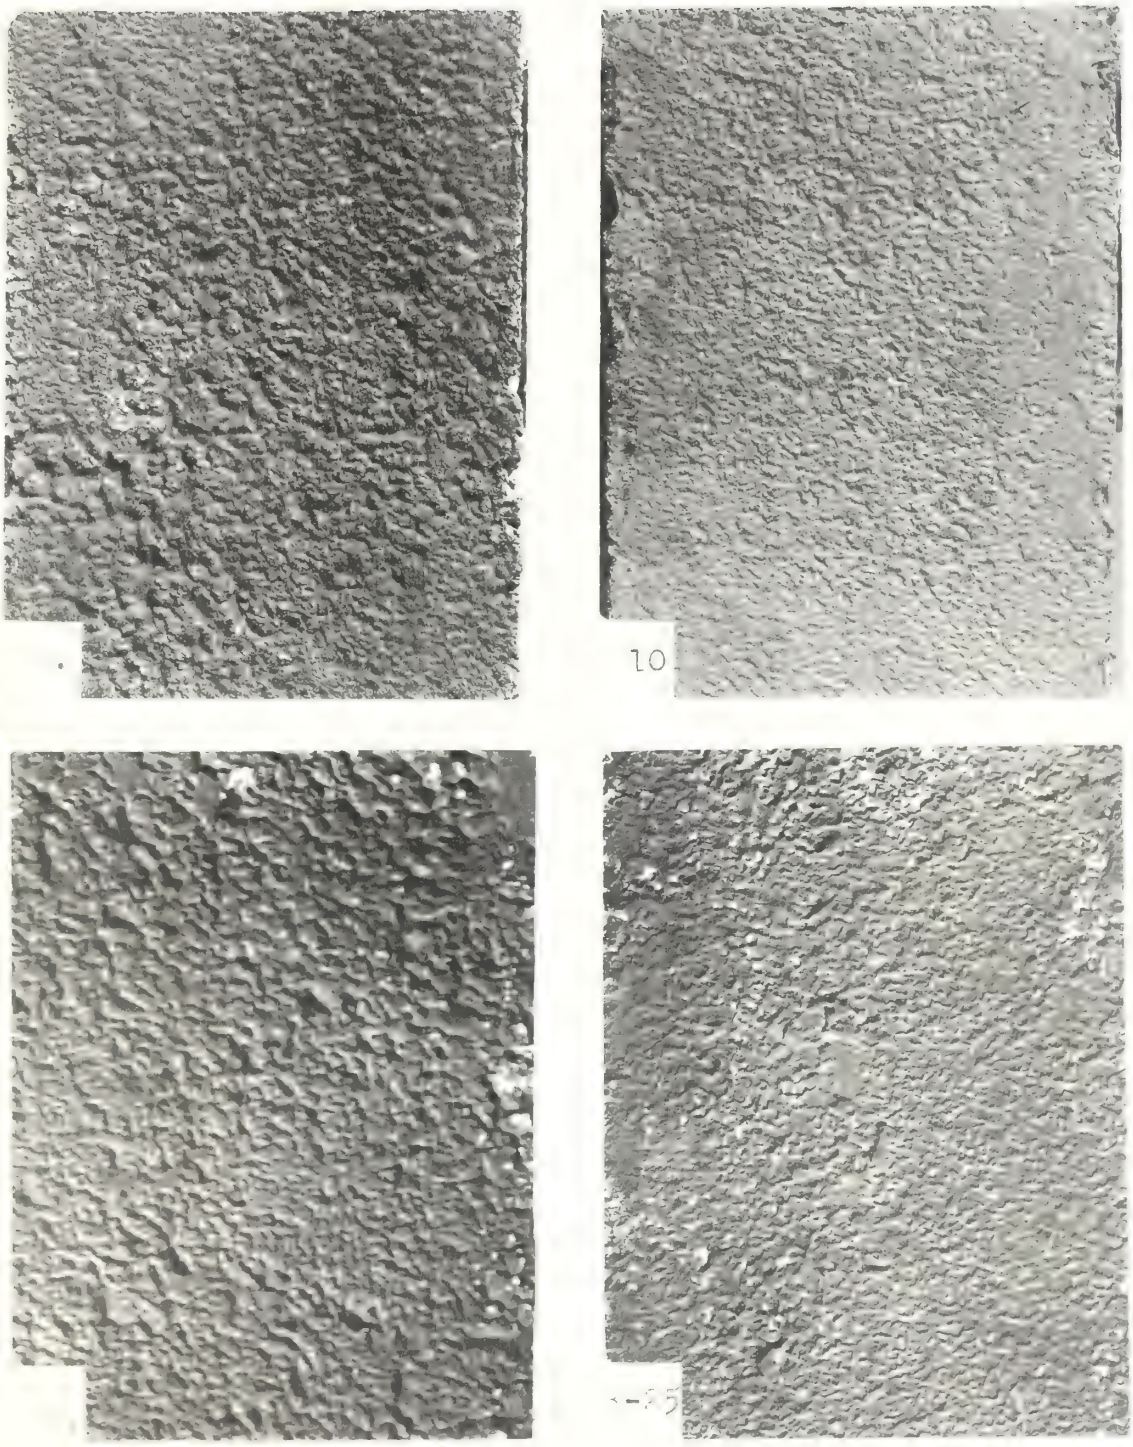
Figure 10. Class III coatings on cinder block - years outdoor exposure.

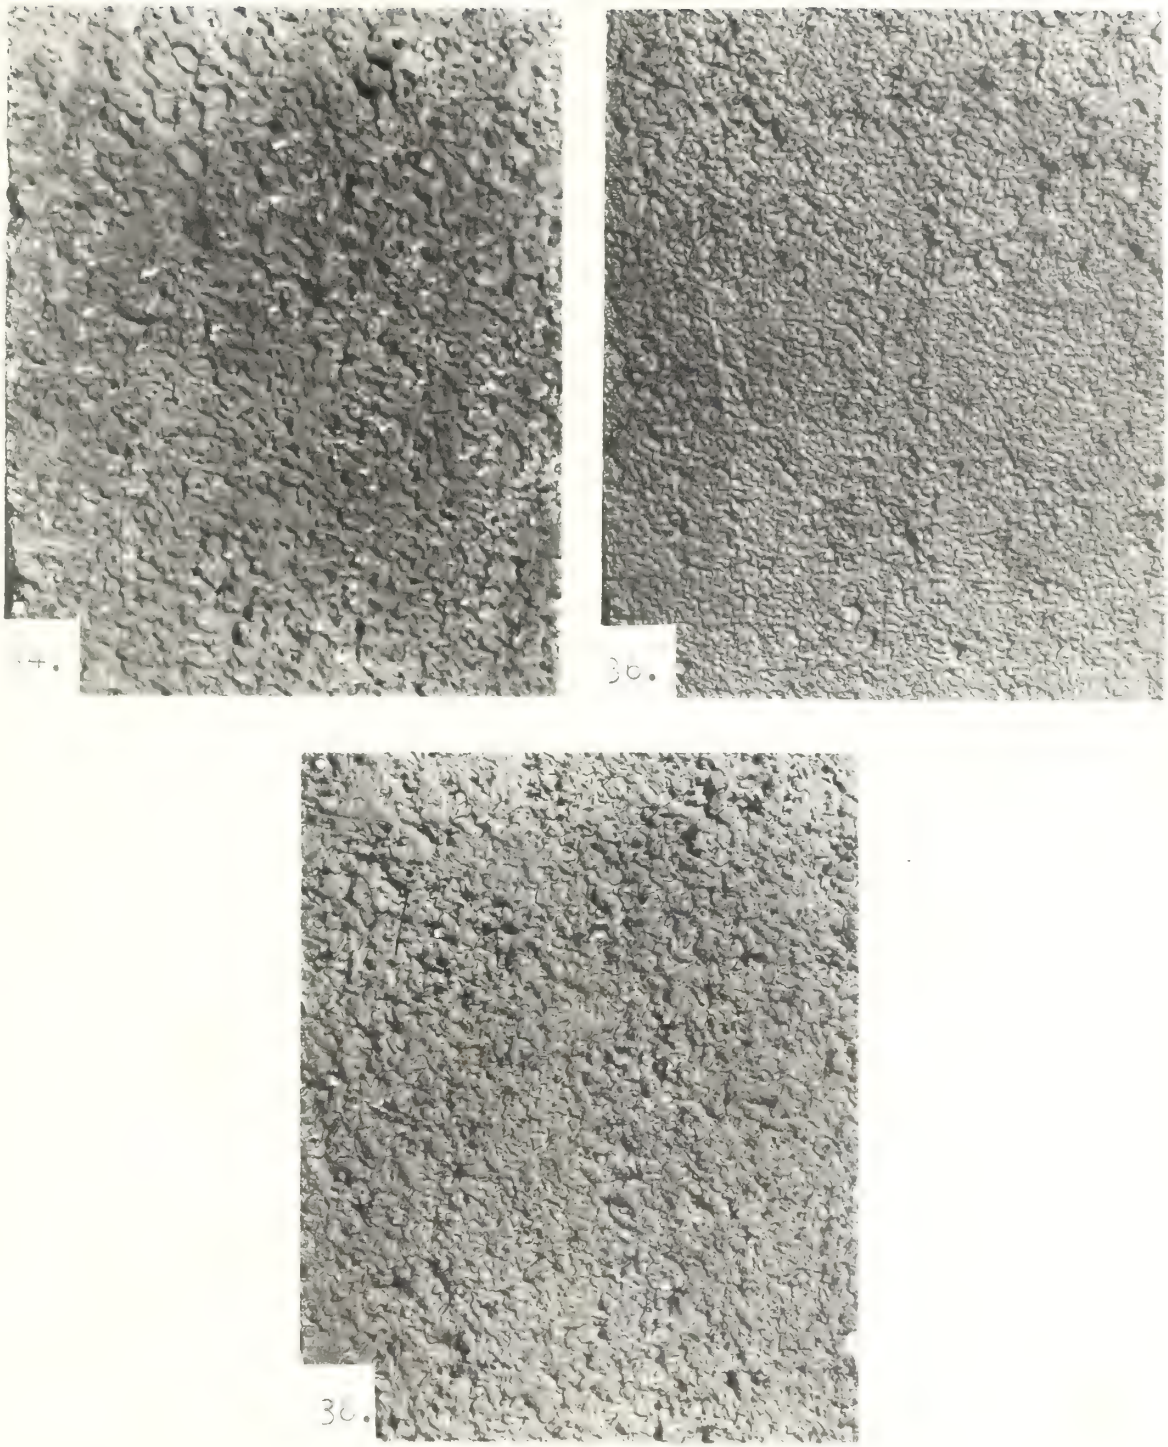
Figure 11. Class III coatings on cinder block - 2 years outdoor exposure.

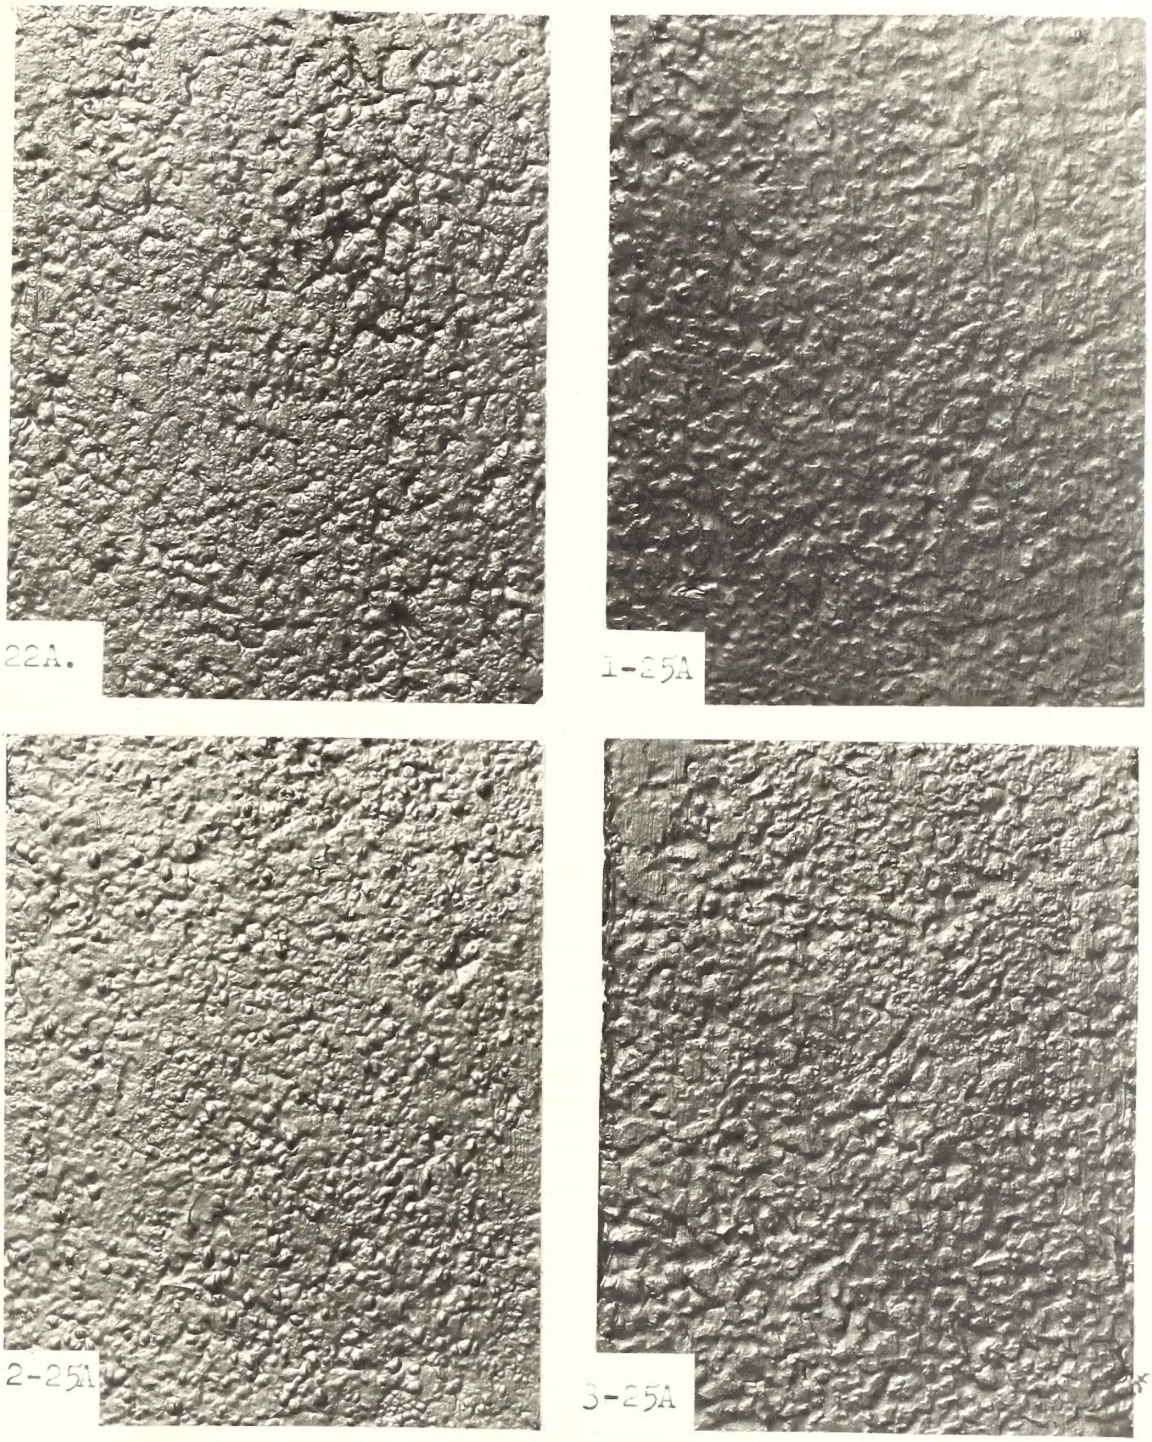
Figure 12. Aluminum paint (coating no. 23) applied to various base coats on cinder block - 2 years outdoor exposure.
